▶ REPORT INTO A FIRE AT RA WOOD
ADHESIVE TAPES CANNOCK ON 5
NOVEMBER 2009

TS09199-R01-ISSUE 1

for:
Kingspan Ltd
GreenField Business Park No 2
Greenfiled
Holywell
Flintshire
CH8 7HU

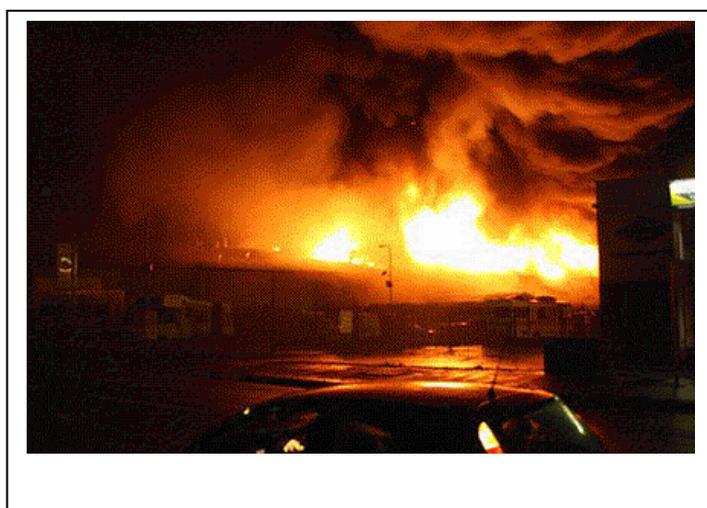
Figure 3- photograph of fire in Express and Star web report

- 3.1 From statements made by I Bullock during the site visit on 16 November, it is understood that the fire started whilst persons were still within the premises in the late evening of 5 November and that suspected ignition event involved a high level light fitting towards the northeast corner of the production area in the RA Wood Adhesives Tapes demise.
- 3.2 We understand that all persons safely evacuated the building without injury.
- 3.3 Press reports posted on the web on 6 November 2009 (Express and Star) reported a very significant fire event requiring attendance by 60 fire service personnel.
- 3.4 Figure 3 (an image provided in the web press report) gives an idea of the intensity of the fire, resulting in penetration of fire through the roof and flaming well above the height of the building.

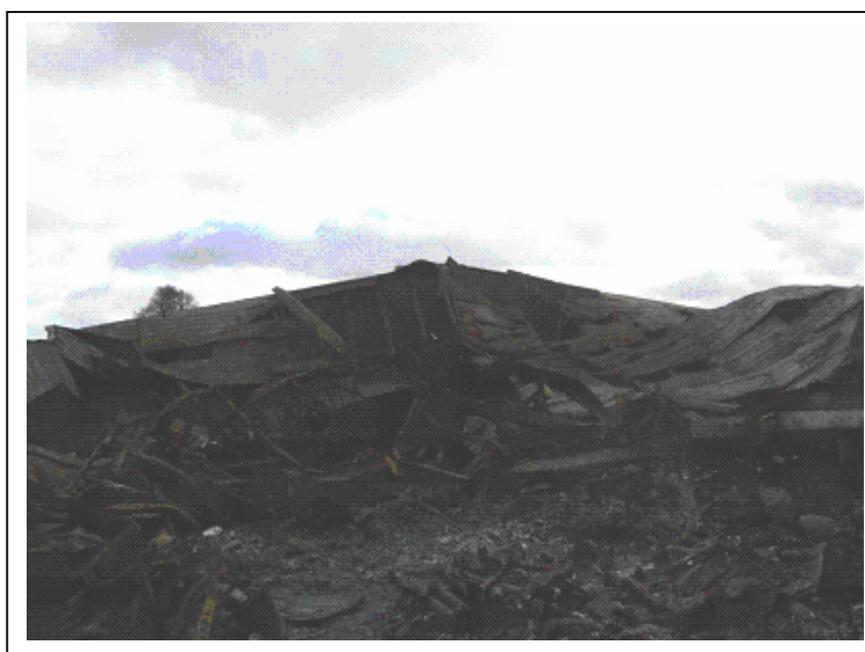
Figure 4 - view from western extremity of the building towards the adjacent demise line

- 4.1 It was clear from the site inspection that the fire load density within the RA Wood Adhesives Building had been significant with the resulting fire being sufficiently intense to result in complete destruction of the covered storage building and the part of the main building occupied by RA Wood Adhesive Tapes.
- 4.2 Figure 4 shows a view from the western most extremity of the building towards the compartment wall (still standing) to the adjacent joinery business demise. The picture illustrates the complete destruction of all roof supporting structure over the production area compartment in the RA Wood Adhesive Tapes demise.

- 4.4 The complete collapse of steel supporting structure shown in Figures 4 and 5, and the presence of melted aluminium from door controls indicates that global temperatures attained in the production area compartment were significantly in excess of 650°C.
- 4.5 The 30 minute fire door and fire rated glazed screen (provided with Georgian Wired Glass) between ground level office accommodation and the production area appeared to have maintained effective separation for a period but eventually lost their integrity.
- 4.6 Figure 6 shows the remnants of the fire resisting glazed screen. The georgian wired glass has fallen from the frame which has been eroded by the fire.

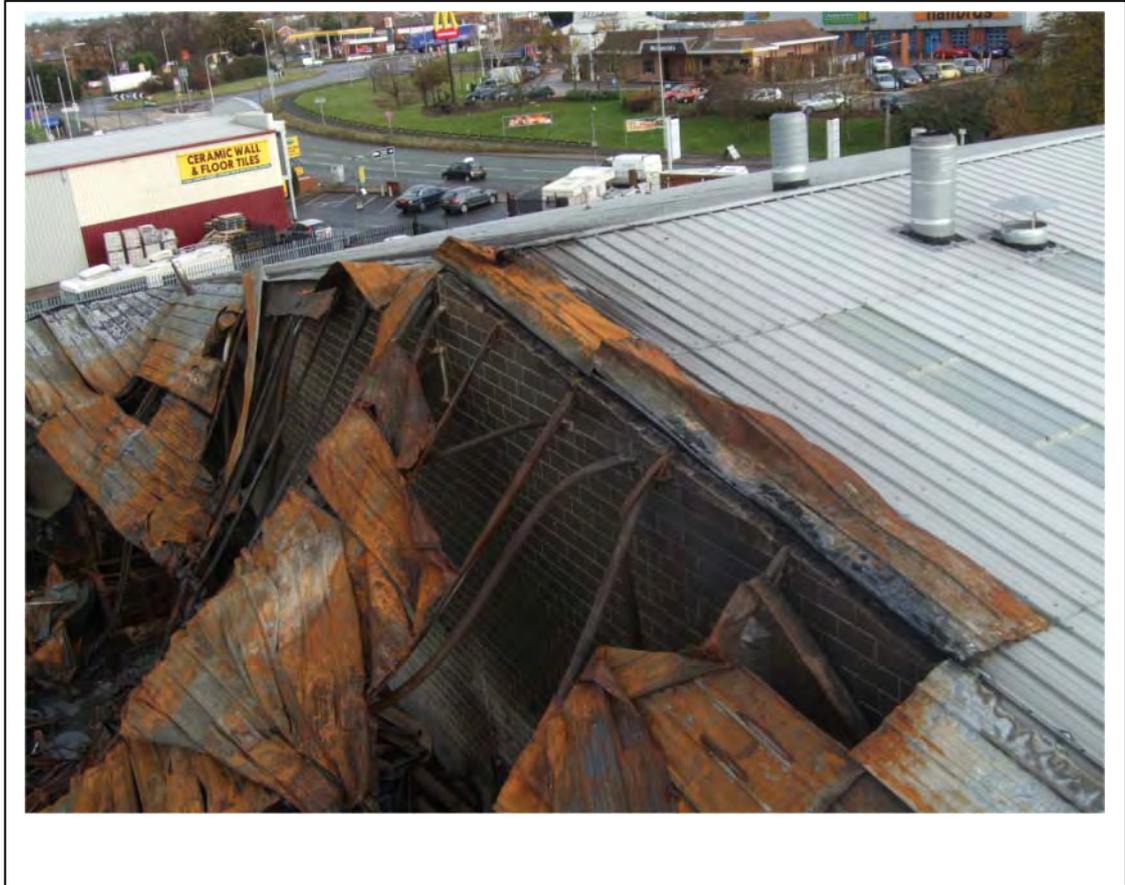
Figure 5 - photograph from high level looking northwards along tenancy separation line

- 4.3 Figure 5 shows a photograph taken from an aerial platform position to the south side of the building and looking along the line of the compartment wall separating the RA Wood Adhesive Tapes demise (to the west) and Joinery company (to the east). The photograph illustrates how the fire has completely destroyed the roof structure to the left whilst the roof over the joinery company demise is still in place.

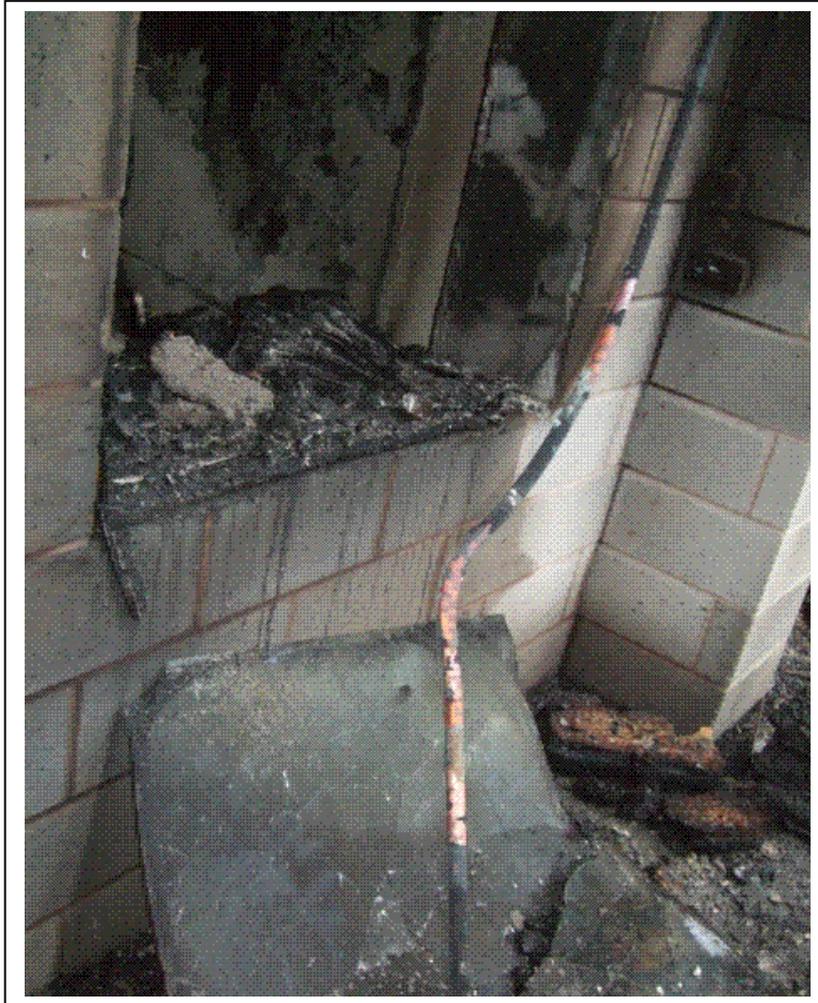
Figure 6 - Effects on fire resisting glazed screen between office and production area

- 4.7 The evidence illustrated in these photographs indicates that the severity of the fire was substantially in excess of that to which 30 minute fire resisting elements of construction would be subjected under standard fire resistance testing procedures to BS476 or BSEN1363.

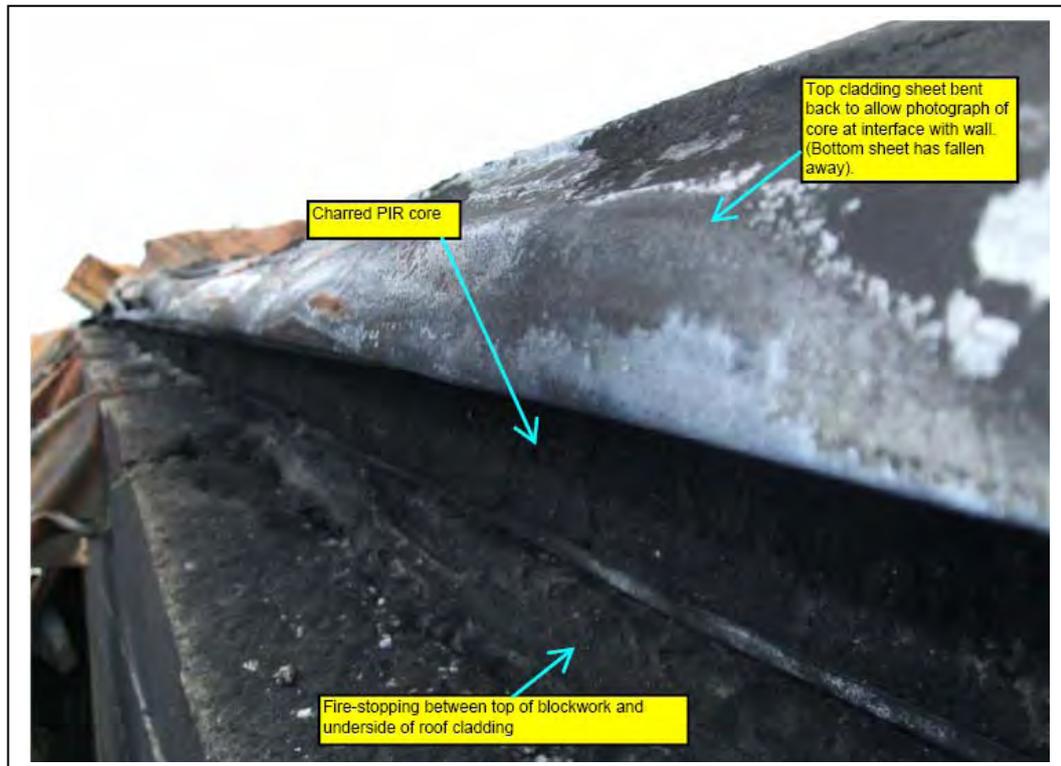
Figure 7 - photograph of head of party wall between tenancies

- 4.10 Figure 7 shows a photograph taken along the head of the blockwork party wall between the tenancies and shows a close-up of the charred PIR core of the roof cladding. The PIR core remained in place to the centre of the blockwork leaf on the RA Wood Adhesive Tapes side of the party wall.

- The fire compartmentation provided by the party wall prevented fire spread from the demise of origin to the adjacent demise.
- The charring exhibited by the PIR core material indicated the formation of a sufficiently stable char within the panel to provide an effective fire stop between the steel skins of the cladding at the head of the compartment party wall.

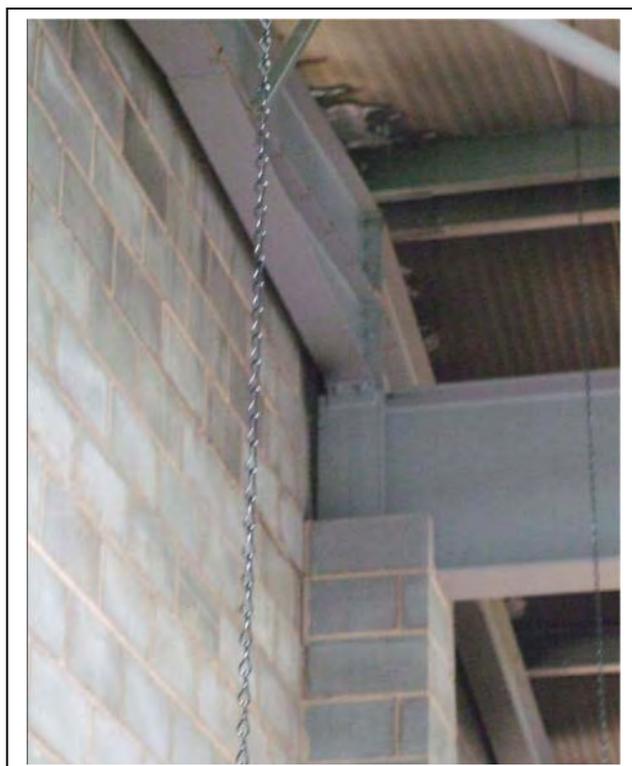
Figure 8 - photograph of underside of roof in Joinery Company demise

4.11 Figure 8 shows a photograph taken from inside the adjacent joinery company demise looking up at the underside of the roof cladding along the party wall line.

- 4.12** It is understood from talking to staff in the joinery company that there was smoke leakage into their demise and this was also evidenced by the striations of smoke staining on the roof soffit and local loss of the PVC coating to the steel skin close to the apex. However, it was clear from the inspection that there was no loss of fire compartmentation provided by the party wall and the fire did not spread to the adjacent demise.
- 4.13** The roof cladding over the joinery company demise remained sufficiently intact to provide continued weather protection to the demise and to allow that business to resume operations shortly after the fire was extinguished by the fire service.
