▼ REPORT INTO A FIRE AT THE SUFFOLK
FOOD HALL ON 27 JANUARY 2010

TS10124-R01

for:
Kingspan Ltd
GreenField Business Park No 2
Greenfiled
Holywell
Flintshire
CH8 7HU

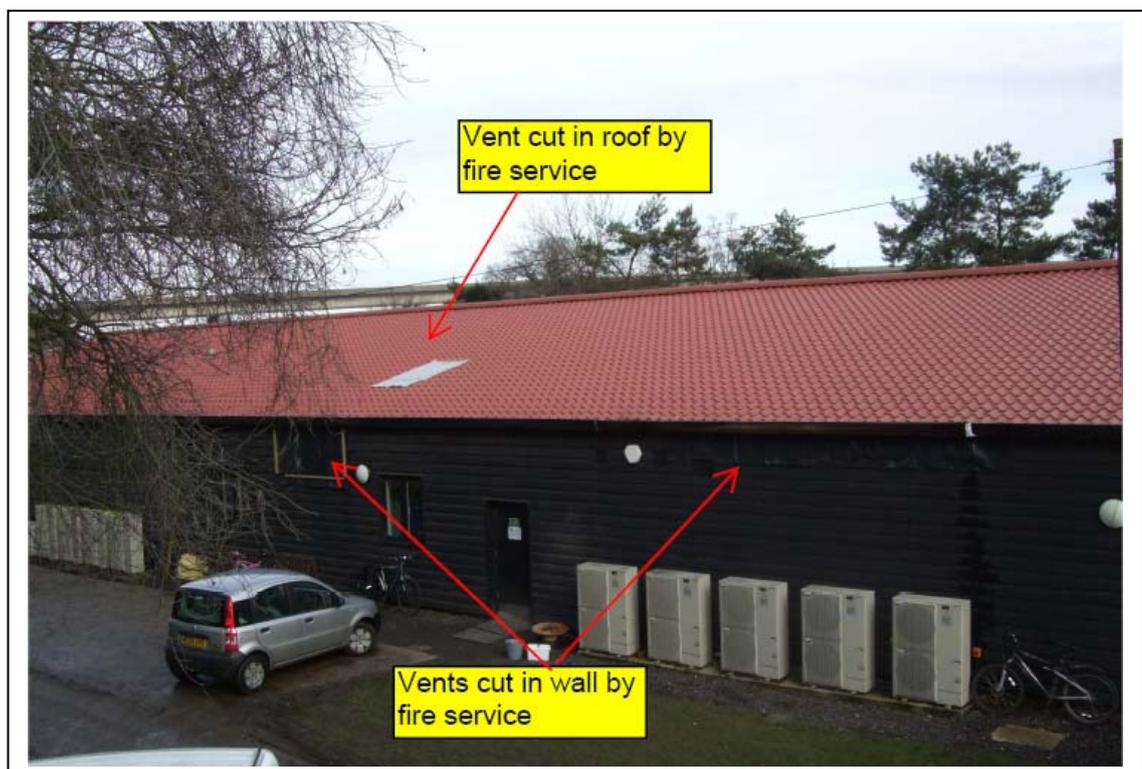
Oliver Paul reported that the fire service took the decision early in the fire-fighting intervention to create an opening through the roof membrane to ventilate the fire location. By virtue of it being a frosty morning, the fire service decided to create a vent in the location where it appeared that the fire intensity was greatest due to fire-induced thawing of frost on the upper surface of the roof in this location. The location of this roof vent is marked up on the photograph shown in Figure 4. The fire service also cut vents in the external wall at the locations shown. The left-most wall vent was into the mezzanine plant area at low level.

Figure 4 - photograph showing vents created by fire service.

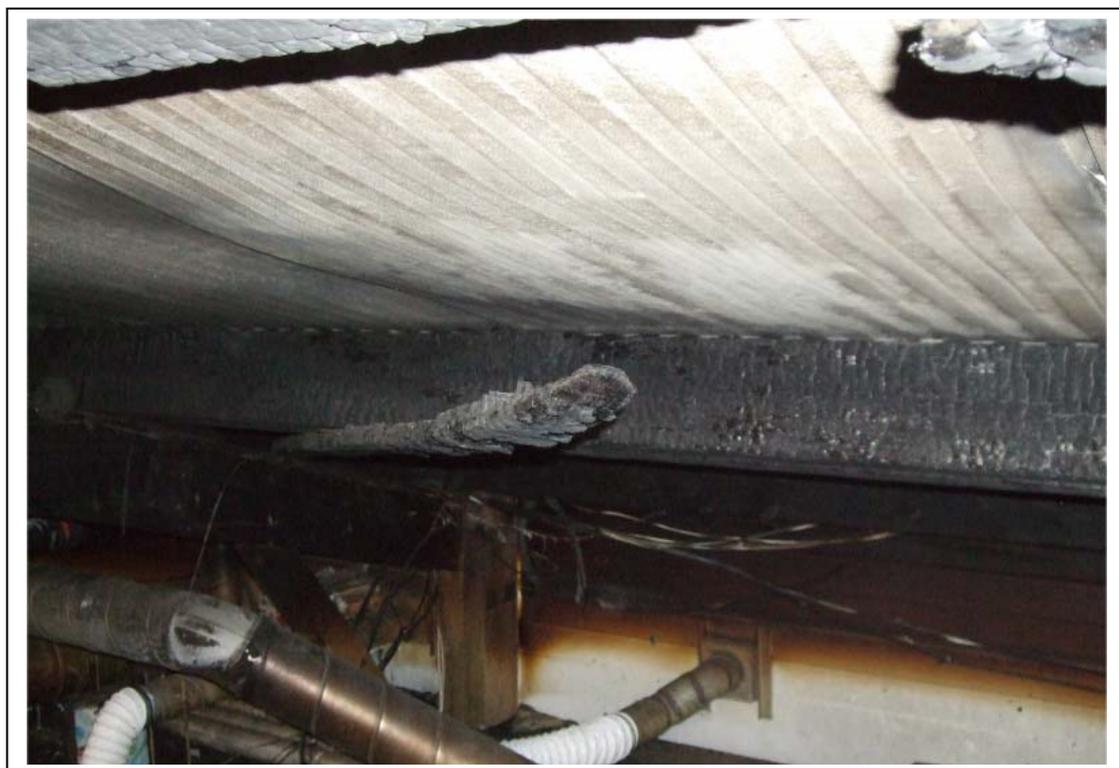
Figure 5 – view of fire damaged area looking down towards the eaves

- 4.5 It was evident that combustible materials at low level had not become generally involved in the fire, therefore indicating that the fire had remained in a fuel bed controlled state and had not flashed over and become ventilation controlled.
- 4.6 However, significant involvement in the fire of combustible services and timber structure at high level positions was clearly evident.

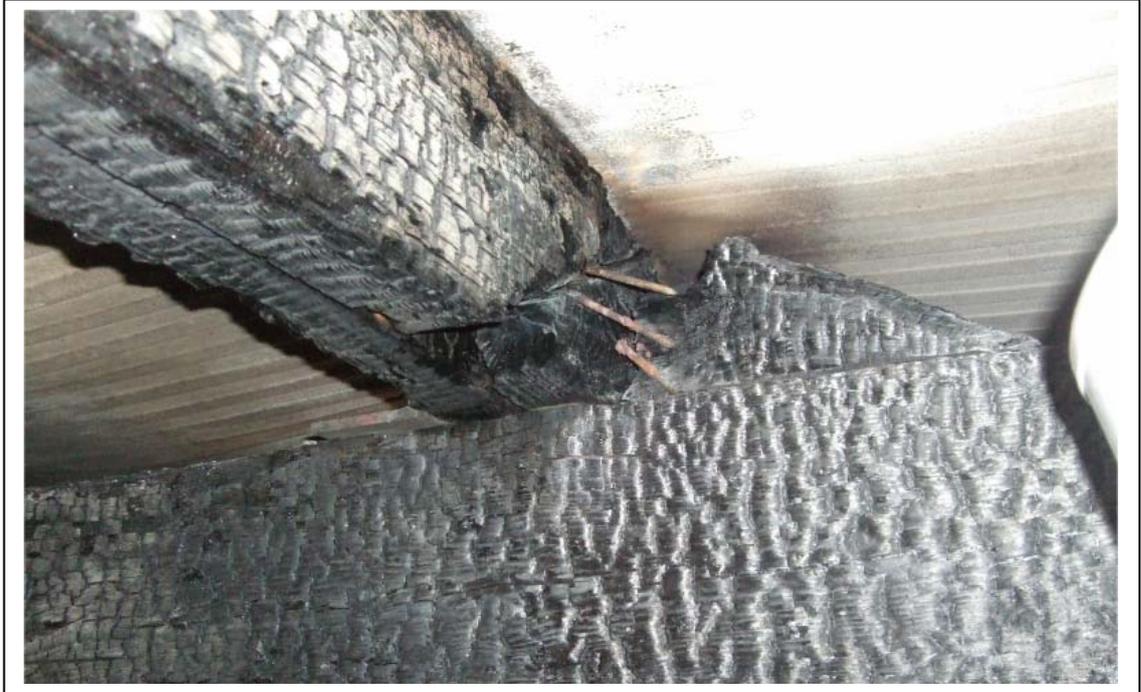
- 4.7 The position where charring of roof support timbers was most significant was approximately 2.7m to the south of the vent that the fire service cut through the roof membrane. At this location, the depth of charring to the main timber rafter was approximately 15mm. Figure 6 shows a photograph of a charred roof support portal at this location.

Figure 6 – charring of roof support portal at position of maximum fire intensity

- 4.8 Based on softwood exhibiting a charring rate of approximately 20mm per half hour of exposure to the conditions of a standard fire resistance test, this indicates that the fire exposure to which the roof had been subjected was approximately equivalent to a 23 minute fire resistance test
- 4.9 At the location where the fire service had created the roof vent, it could be ascertained from the visual inspection that the fire exposure had resulted in partial through-thickness charring of the PIR core material of the roof membrane sandwich panels. Figure 7 shows a photograph of the core material close to the location where the fire had been most intense.
- 4.10 Whilst the PIR core was charred through part of its thickness, there was no evidence to suggest that the fire had been propagated through the insulating material core of the panel.

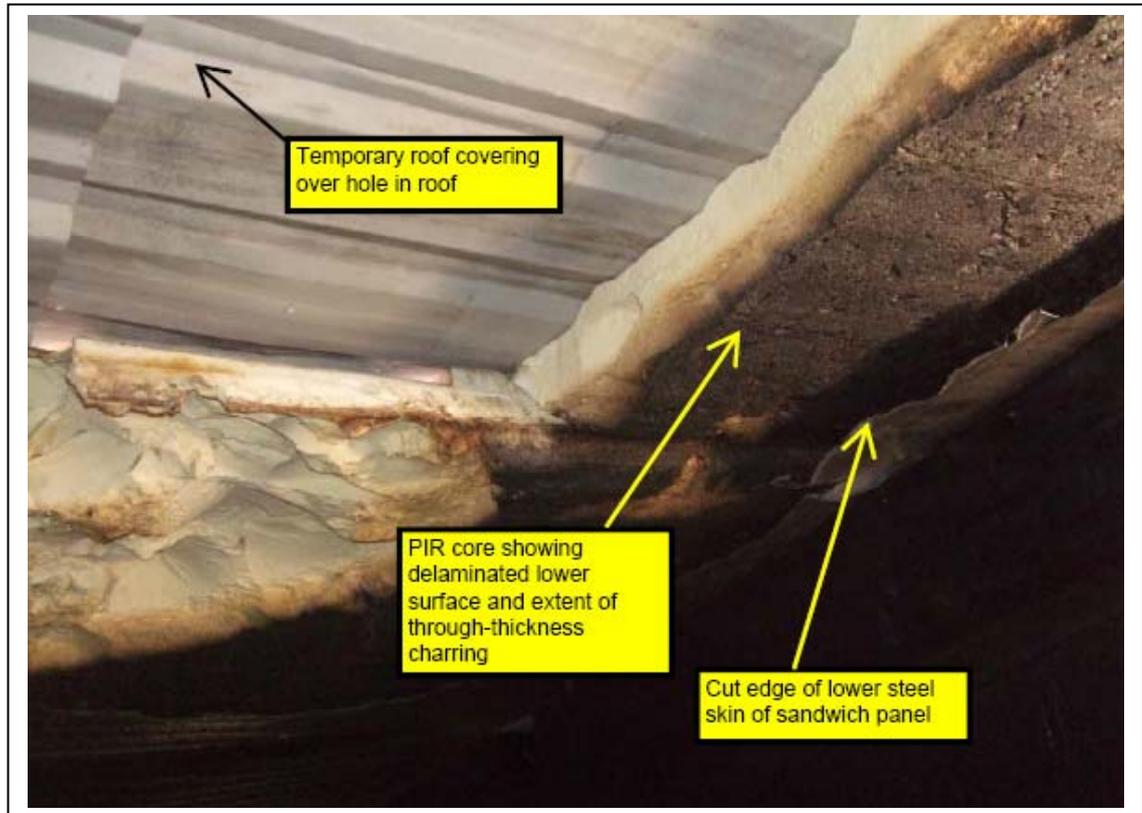
Figure 7 – charring of sandwich panel PIR core

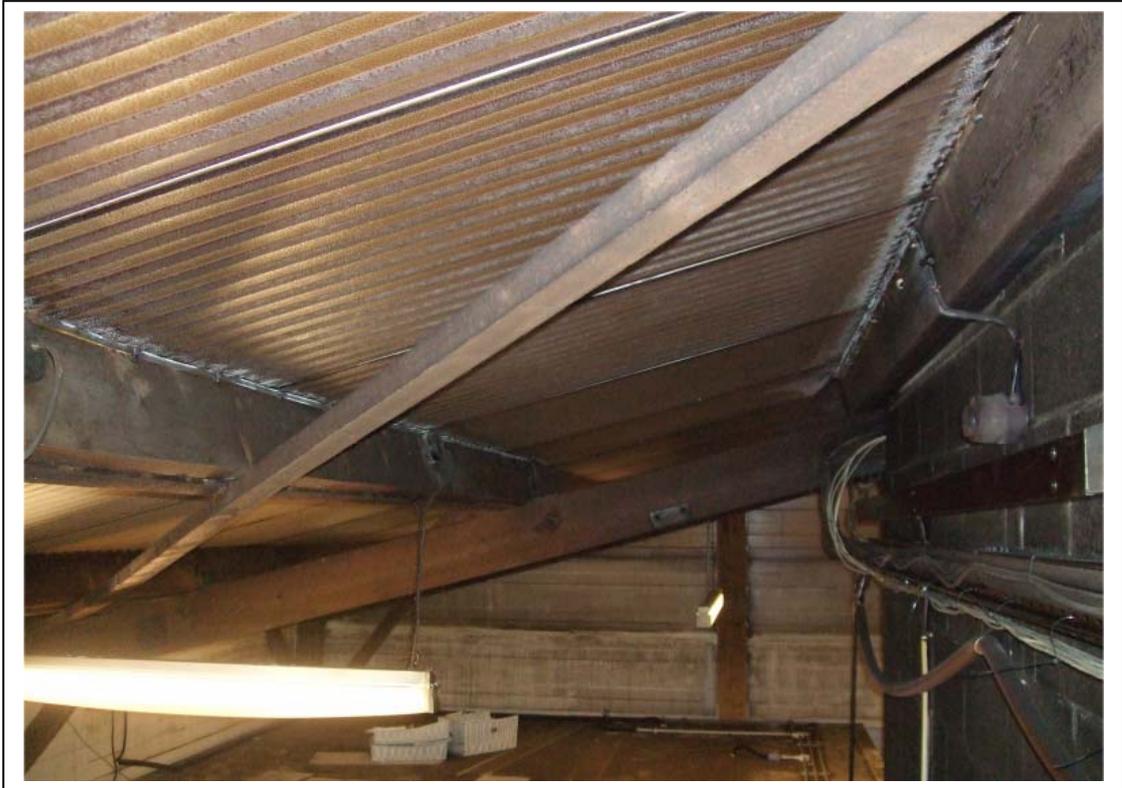
- 4.11 It was established that the lower skin of the roof membrane sandwich panels had delaminated from the PIR core over the parts of the mezzanine area that had been subject to the greatest fire intensity. This delamination was evident wherever there was evidence of charring of roof timbers. The further north along the mezzanine area, the lesser was the fire intensity and, at a point over the ground level chillers, it was apparent that the roof membrane from this point to the northern extremity of the building was not delaminated. Figure 8 shows a photograph of the roof looking northwards from the plant mezzanine area. Although the timbers have been stained by hot smoke, there was no evidence of penetrative charring of the roof timbers in this area.

Figure 8 – view looking from the plant mezzanine level towards north wall

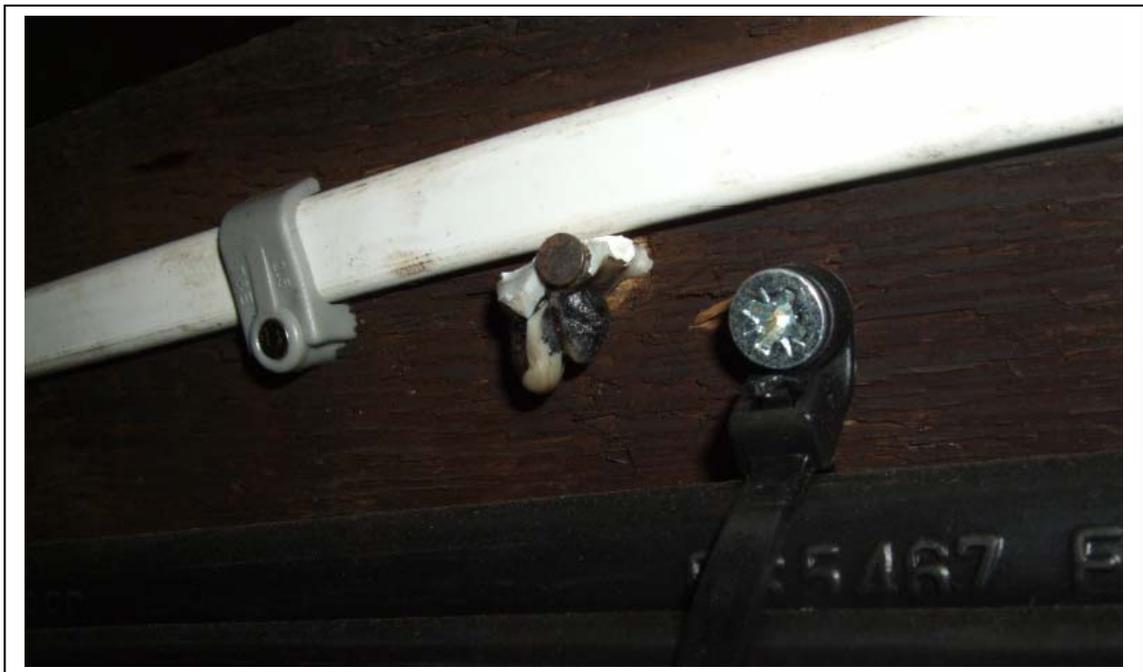
- 4.12 Figure 9 shows a photograph of smoke stained timbers in this area where new electrical services have been replaced and where previous PVC cable fixings had melted. At this location the lower skin of the roof membrane exhibited delamination from the core.

Figure 9 – melted cable clip on smoke stained timber

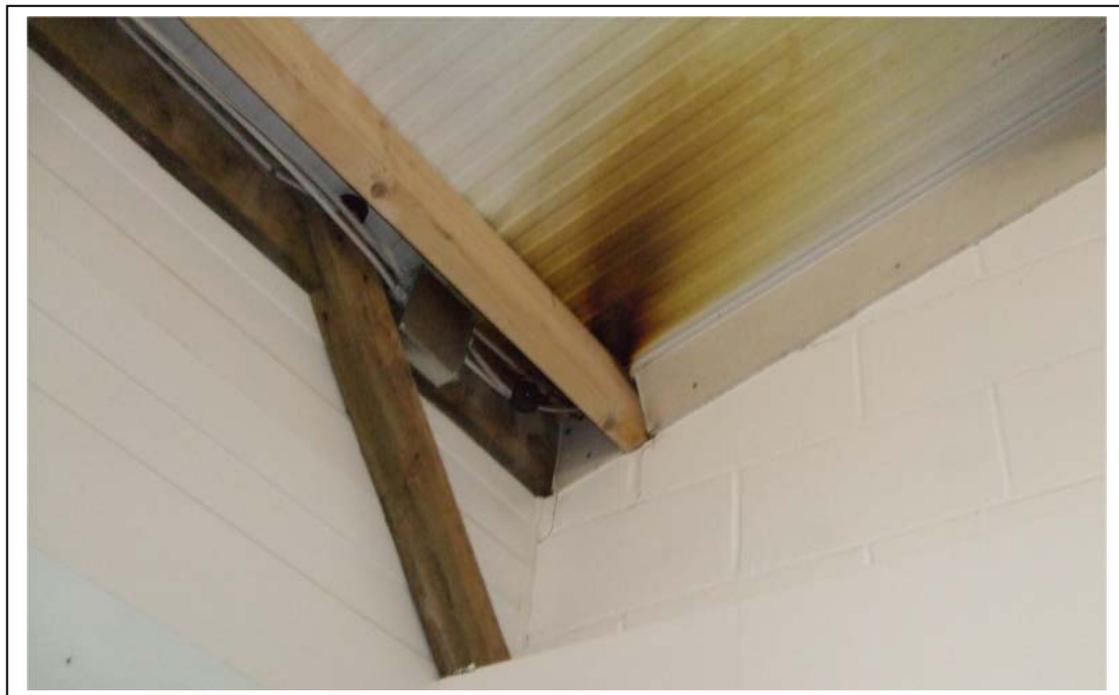
- 4.14 Figure 11 shows a photograph taken from inside the adjacent Bourne Garden Centre demise looking up at the underside of the roof cladding at the south western corner of the wall to the mezzanine plant area.

Figure11 - photograph of underside of roof in adjacent demise

- 4.15 The photograph shows evidence of smoke penetration through gaps and also indicates that the fire did not spread along timber roof support members or services passing through this wall.
