REPORT INTO A FIRE AT SPIDER TRANSPORT
RATHNEW WICKLOW

Kingspan Ltd
GreenField Business Park No 2
Greenfield
Holywell
Flintshire
CH8 7HU

TS08194-R01-Issue 2a

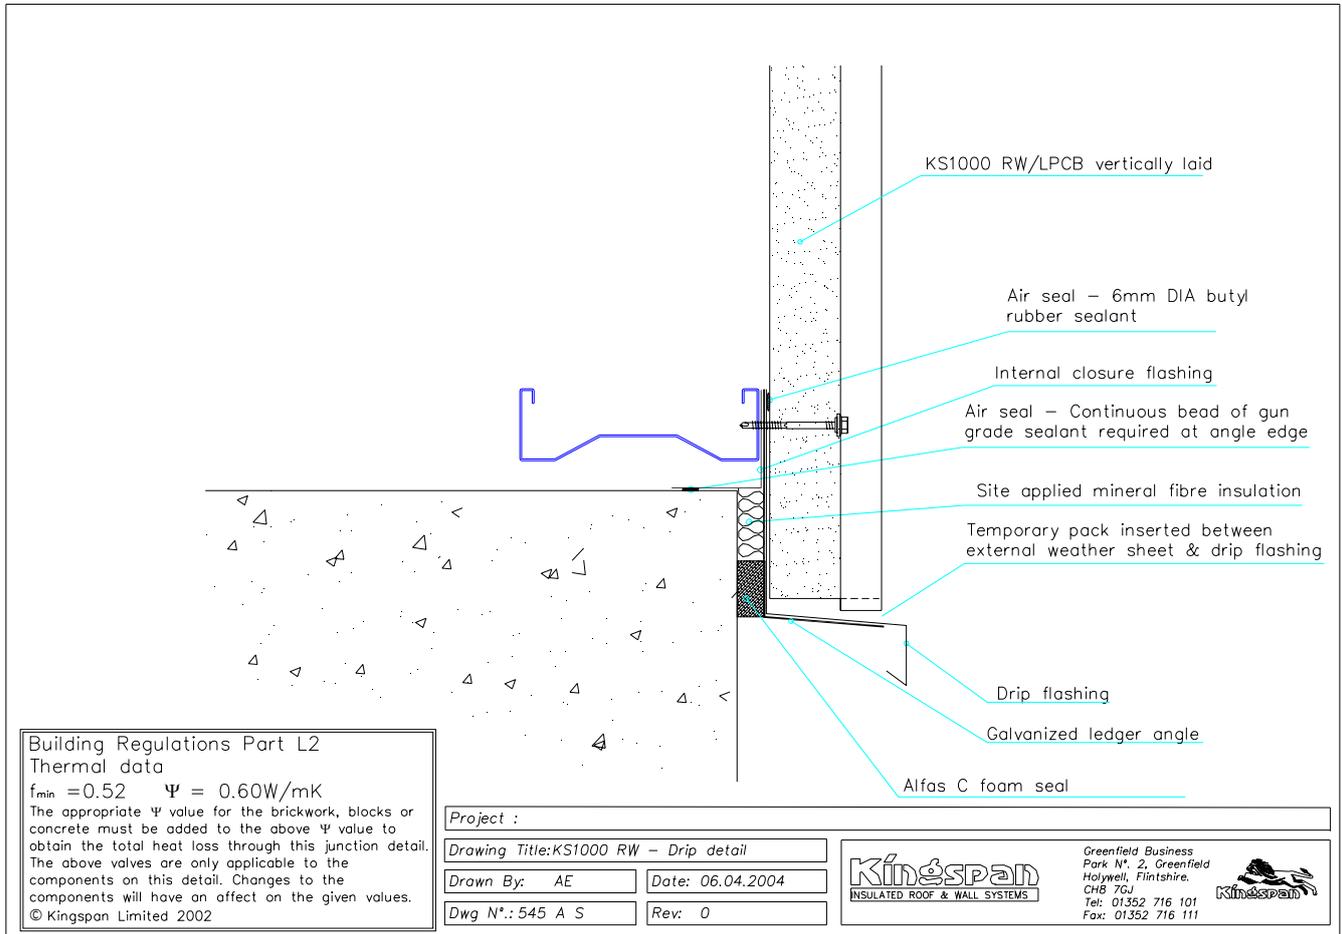
- 2.3 Drawing 1 at Annex 1 shows the detail of how the Kingspan insulated panels (KS 1000 RW) were fixed to the blockwork wall. Of particular note is that there is a design gap between the drip flashing and the bottom edge of the Kingspan insulated panels (KS 1000 RW). This gap above the drip flashing coupled with the corrugated profile of the Kingspan insulated panels (KS 1000 RW); (see photographs 7 and 8 at Annex 3); meant that the bottom of the insulating core of the Kingspan insulated panels (KS 1000 RW) was exposed to any flame impingement on that part of the blockwork wall and the cladding above.

- 5.3 The edges of the Kingspan insulated panels immediately above the up and over door were subjected to the radiated heat from the burning vehicle and the heat from the burning insulation within the up-and-over door. Drawing 1 at Annex 1 shows the detail of how the Kingspan insulated panels (KS 1000 RW) were fixed to the blockwork wall. Of particular note is that there is a design gap between the drip flashing and the bottom edge of the Kingspan insulated panels (KS 1000 RW). This gap above the drip flashing coupled with the corrugated profile of the Kingspan insulated panels (KS 1000 RW); (see photographs 7 and 8 at Annex 3); meant that the bottom of the insulating core of the Kingspan insulated panels (KS 1000 RW) was exposed to any flame impingement on that part of the blockwork wall and the cladding above. Although the core of the Kingspan insulated panels (KS 1000 RW) above the up-and-over door charred, there was no delamination of the skins of the panels and the insulation remained in place.

Drawing I. Detail of fixing of cladding to blockwork wall and drip flashing

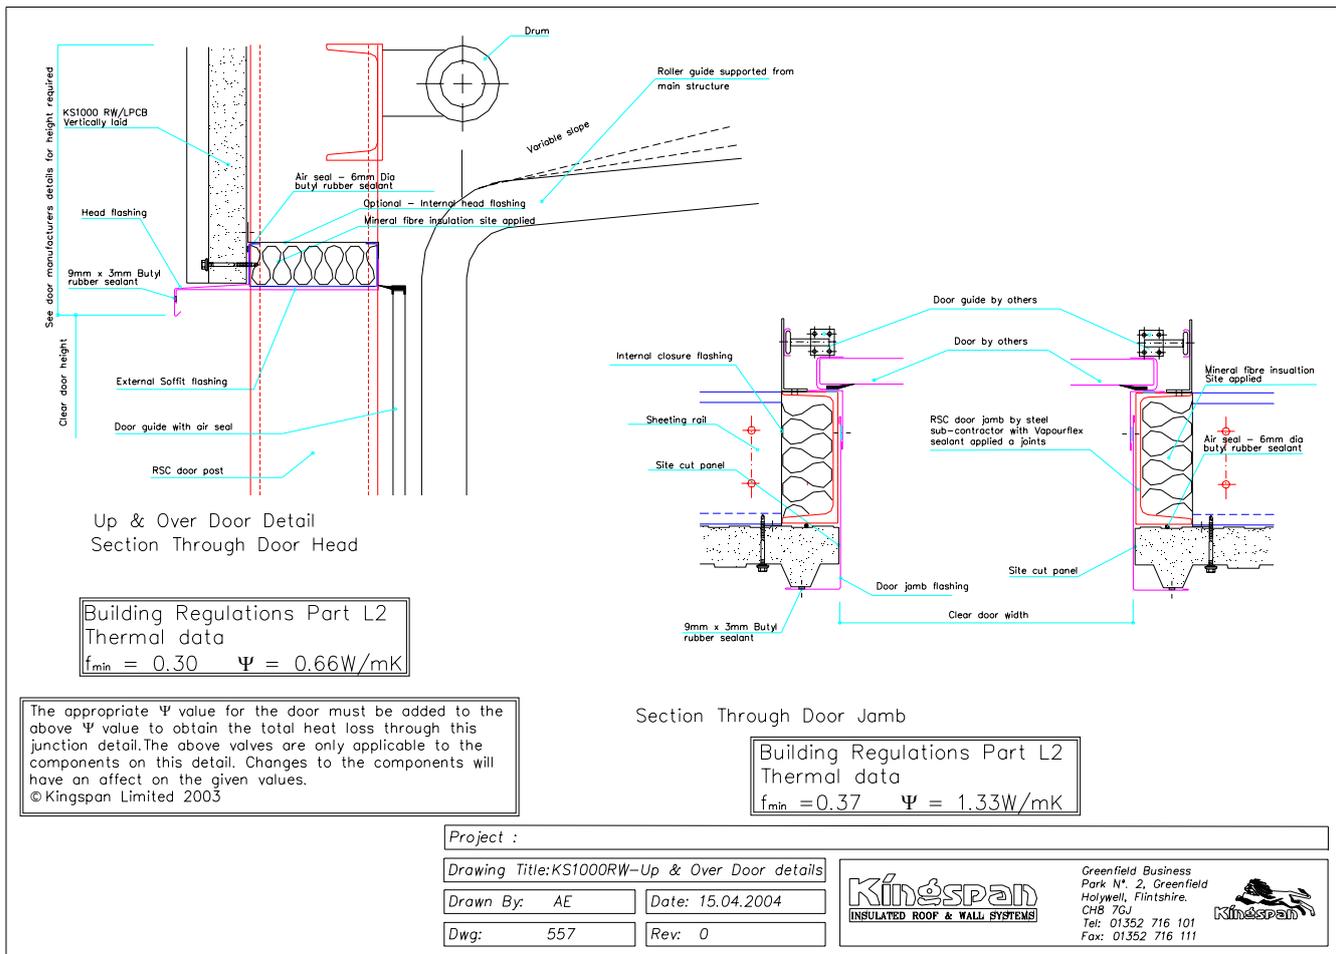
- 2.4 A similar set of circumstances occurred above the up-and-over door between the head flashing and the bottom edge of the Kingspan insulated panels (KS 1000 RW) (see Drawing 2 at Annex 1)

- 5.4 The lower edges of the Kingspan insulated panels (KS 1000 RW), immediately above the proprietary wall had also charred at the edge nearest the up-and-over door; where there was a gap between the head flashing and the bottom edge of the Kingspan insulated panels (KS 1000 RW) (see Drawing 2 at Annex 1). However, the core had remained in-situ and there was no evidence of deformation or delamination. There were no signs of any spread of heat via the cores of the Kingspan insulated panels (KS 1000 RW) to any point within the building and no signs of spread within the cores of those panels.

Drawing 2. Detail of fixing of cladding and head flashing above up and over door

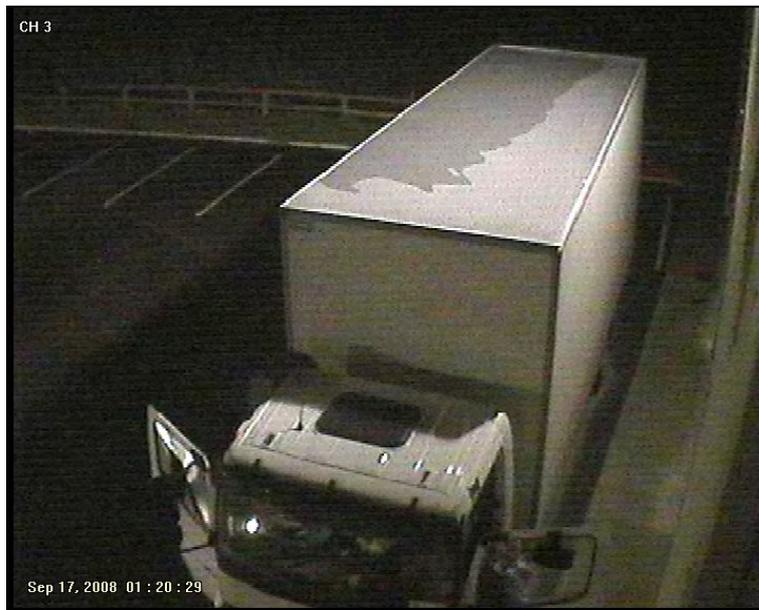
- 3.2 Annex 2 shows a series of still images taken from an external CCTV security camera during the fire. It is not known if the timings shown on the CCTV were synchronised with national time but for the purposes of this investigation the important factor is the time during which the fire posed a hazard to the building. Image 1 shows the first ignition of something inside the cab of the vehicle at 01:20:29.

Image 1. Security Video time 01:20:29 - first ignition

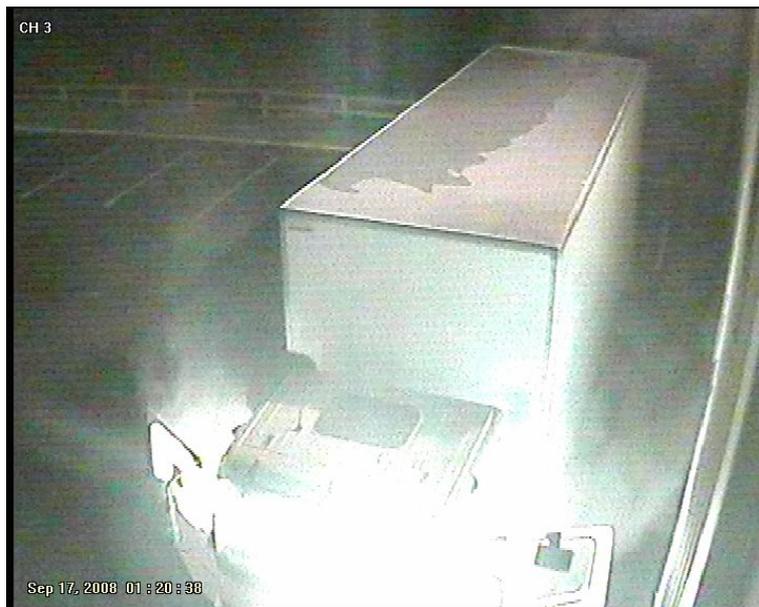
Image 2. Security Video time 01:20:38 – cab interior fully involved

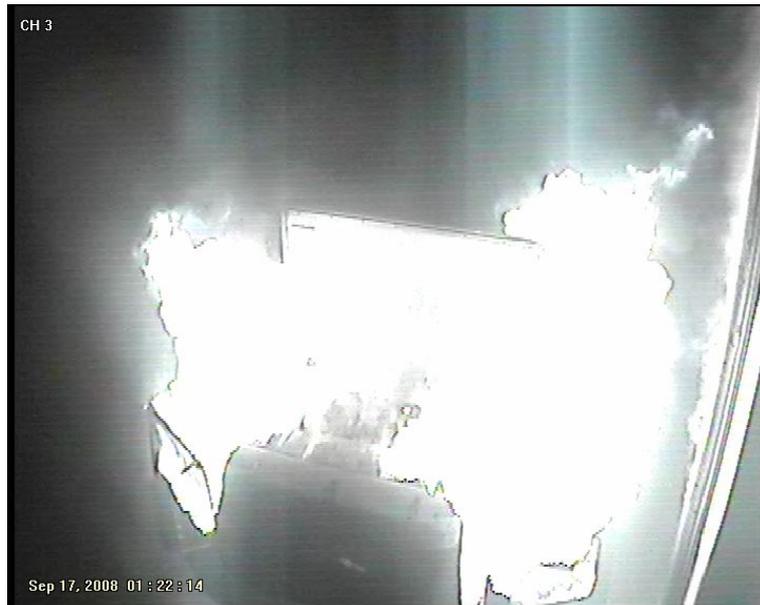
Image 3. Security Video time 01:22:14 – flames impinging on building and initial production of fumes from building cladding

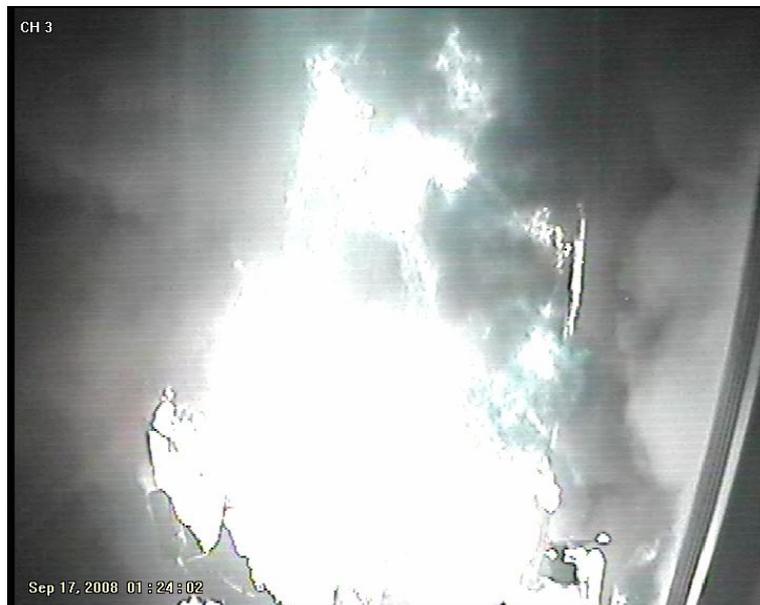
Image 4. Security Video time 01:24:02 – significant increase of fire development in the vehicle

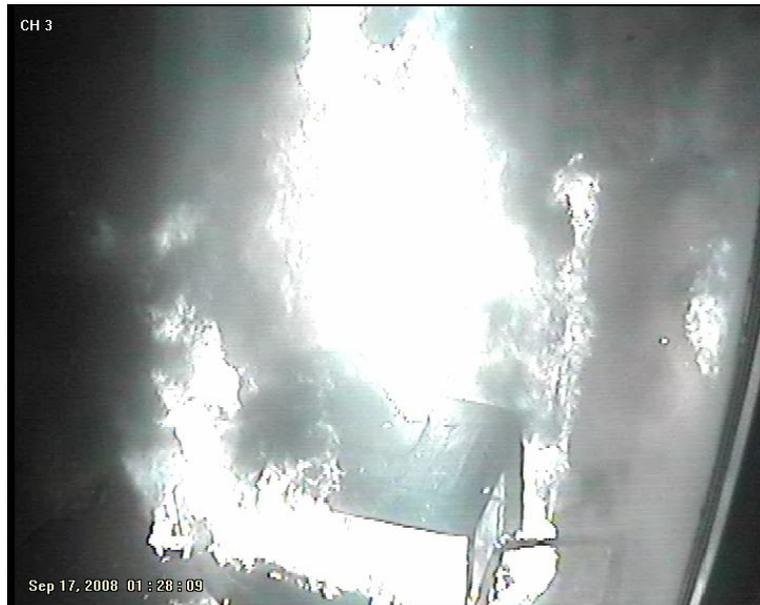
Image 5. Security Video time 01:28:09 – further significant increase of fire development in the vehicle with fire spread from the cab to the front of the vehicle body – small flame on building cladding

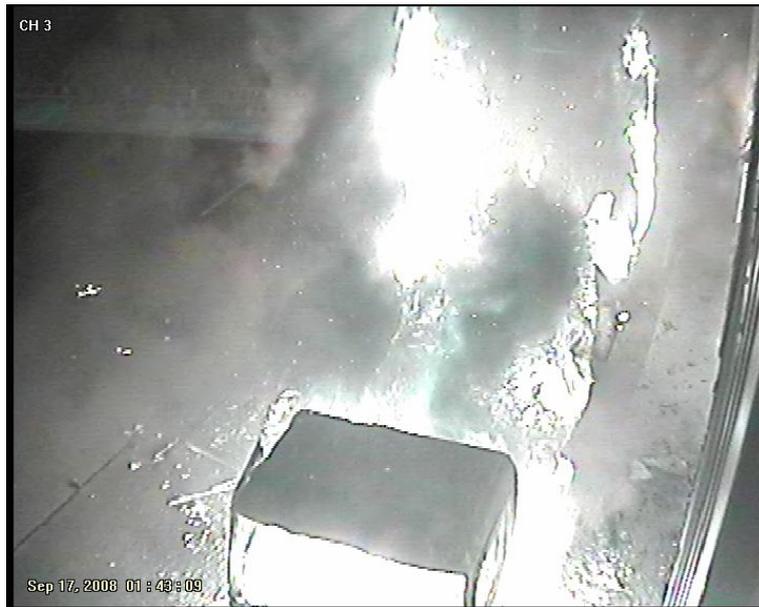
Image 7. Security Video time 01:43:09 – all of vehicle cab and body involved with significant destruction of both

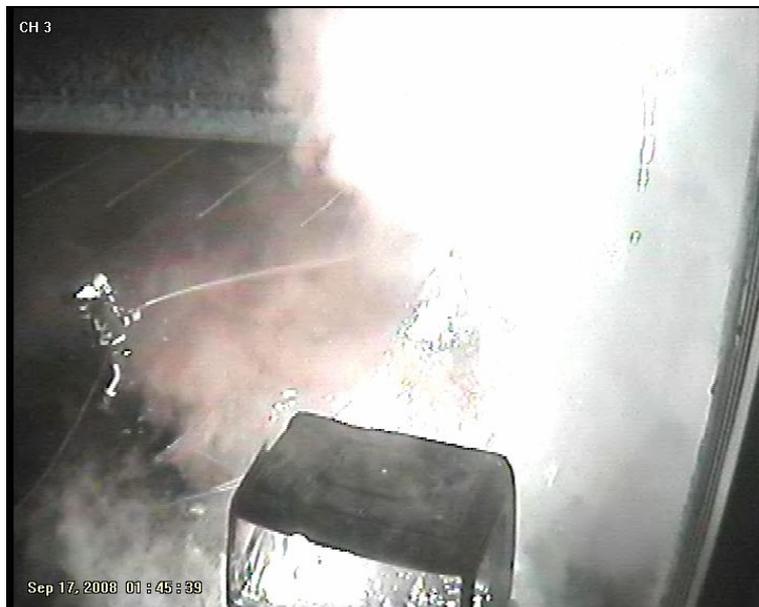
Image 8. Security Video time 01:45:39 – first firefighting jet deployed

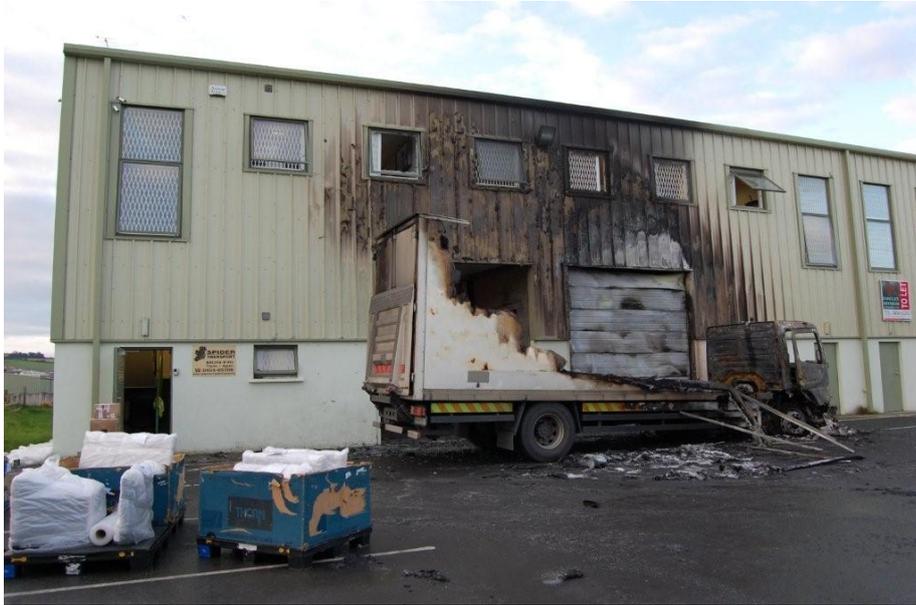
- 3.6 Radiated heat caused damage to the cladding of the blockwork wall and the Kingspan insulated panels (KS 1000 RW) above the blockwork wall and above both of the up-and-over doors (see Photographs 1 & 2 at Annex 3).

Photograph 1. The part of the premises occupied by Spider Transport extended from the gable at the left to the downspout adjacent to the 'To Let' sign at the right.

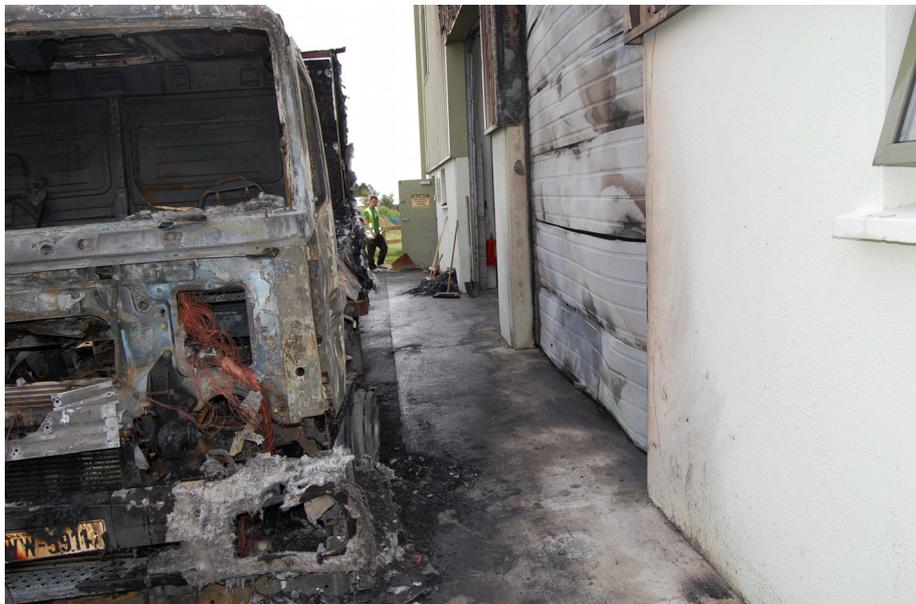
Photograph 2. The van had been parked approximately one metre from the wall of the premises. Note discolouration of the wall covering immediately adjacent to the vehicle cab. The up and over door on the left was still operational after the fire.

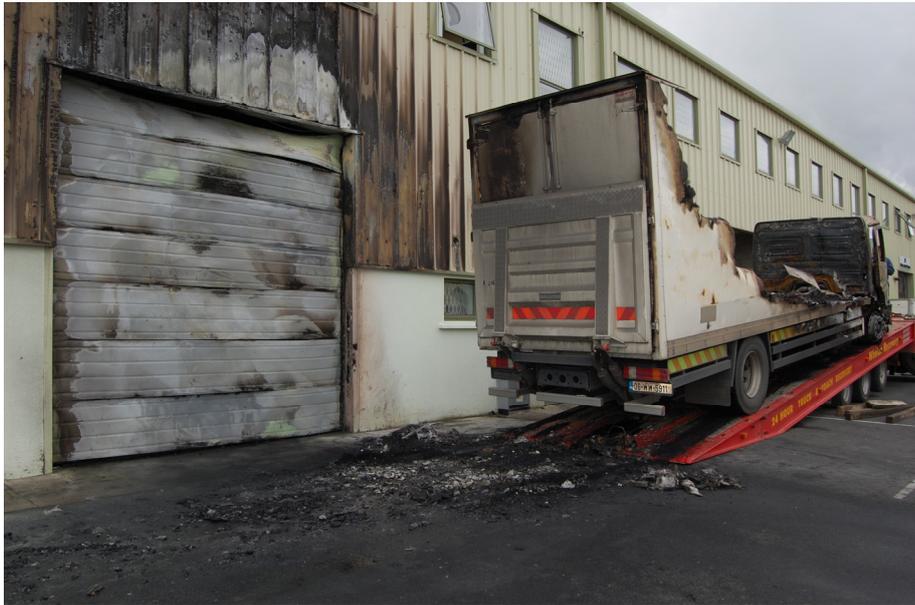
- 3.7 The up-and-over door nearest to the front of the vehicle (on the right when looking at the building from outside), sustained heat damage both on the outside and the inside of the door (see Photographs 1 to 4 at Annex 3). There was also fire damage and smoke staining visible to the ceiling and walls of the 'tunnel' to which this door gave access. The Kingspan insulated panels (KS 1000 RW) above this door also showed significantly greater heat damage than the other panels damaged during the fire. In view of this pattern of damage, and the fact that the adjacent up-and-over door and 'tunnel' were relatively undamaged suggests that the heat flux projected onto the building was greatest towards the front of the vehicle and that the insulating core within the up and over door contributed to the fire.

Photograph 3. Heat damage to the full face of the up and over door and to the lower edges of the Kingspan insulated panels (KS 1000MR) above the blockwork wall and above the up and over door.

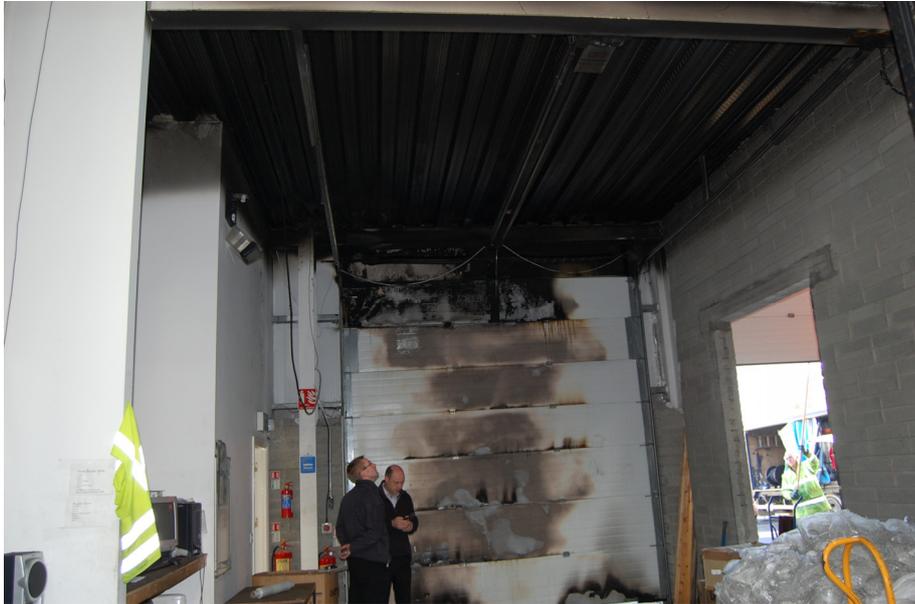
- 4.6 From the extent of the fire damage and smoke staining visible in Photographs 4 and 11 at Annex 3; to the up-and-over door; the ceiling and upper side walls of the 'tunnel' and the wall at first floor level; it would appear that the foam insulation within the up-and-over door contributed to the spread of the fire. For comparison purposes; see the lack of any damage to the ceiling and upper side walls of the 'tunnel' and the wall at first floor level at the adjacent unit shown at Photograph 14; where the up-and-over door had not been subjected to the same radiated heat as the other door.

Photograph 4. Interior of the up and over door showing evidence of heat damage at low level, increasing at the top of the door and smoke staining to the underside of the mezzanine floor 'tunnel'. The wall opening to the right gave access to the adjacent unit also occupied by Spider Transport. The roller-shutter door to that unit is in the open position.

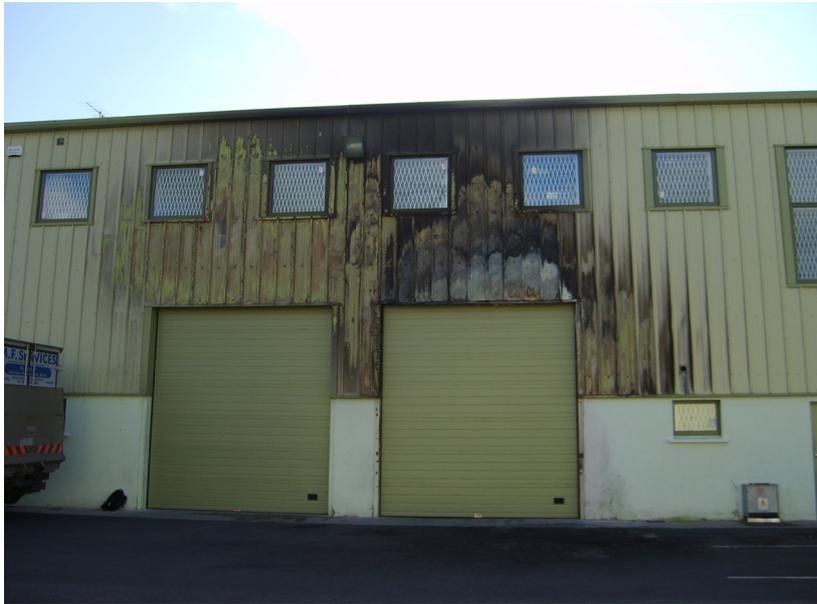
- 4.1 At the date of the visit on 28th October 2008 the two up-and-over doors had been replaced (see Photograph 5 at Annex 3).
- 4.2 An examination of the Kingspan insulated panels (KS 1000 RW) both above and at the sides of the up and over doors showed the outer and inner skins to be intact with no deformation. In fact it was extremely difficult to prise open the outer skins to examine the inner core.

Photograph 5. The front of the building on 28th October 2008. Both of the up and over doors had been replaced as had the broken windows.

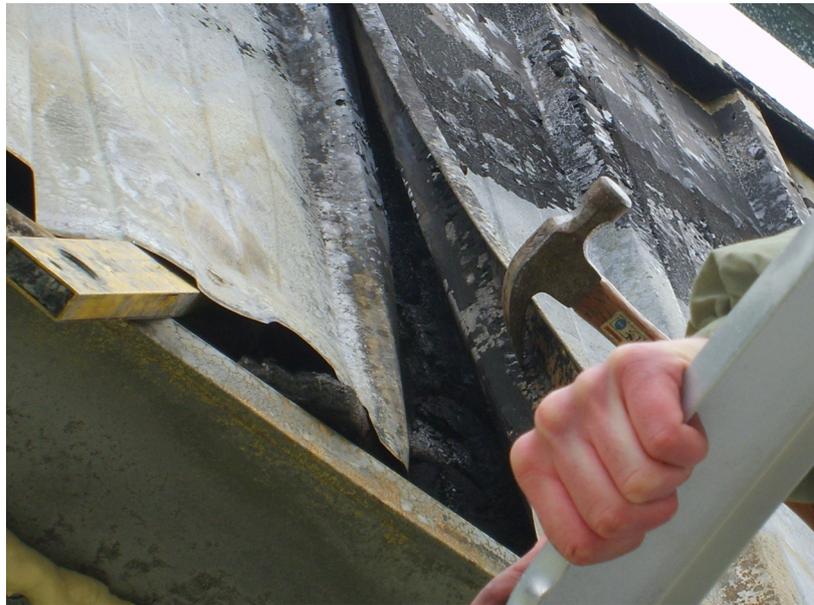
- 4.3 The lower edges of the Kingspan insulated panels (KS 1000 RW) immediately above the up and over door on the right were prised open. The inner core had charred but had remained in-situ and there was no evidence of deformation or delamination (see Photographs 6 & 7 at Annex 3). In addition, there was no evidence that the core of the Kingspan insulated panels (KS 1000 RW) had assisted fire spread.

Photograph 6. The lower edges of the panels immediately above the up and over door being prised open. Charred insulation, which had remained in-situ throughout the fire, fell from the insulated panel as this work was being done.

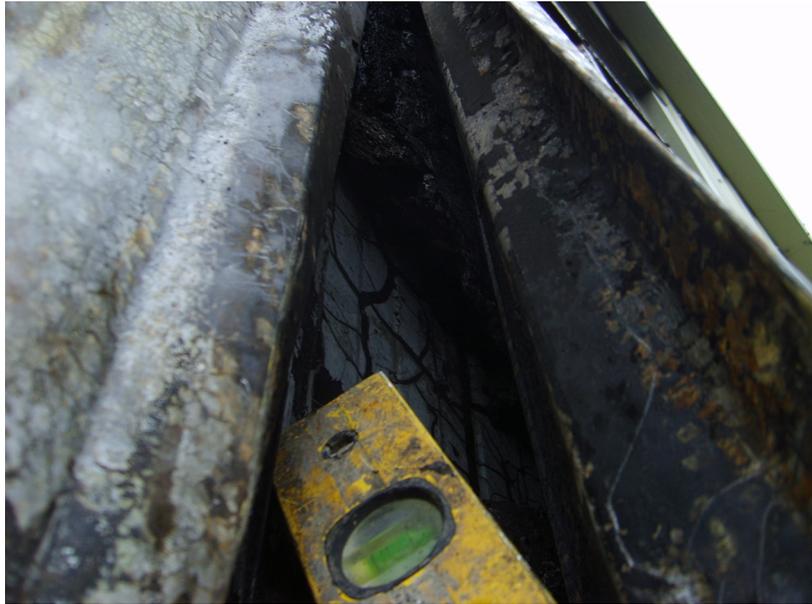
Photograph 7. The charred insulation that had remained in place throughout the fire above the up and over door.

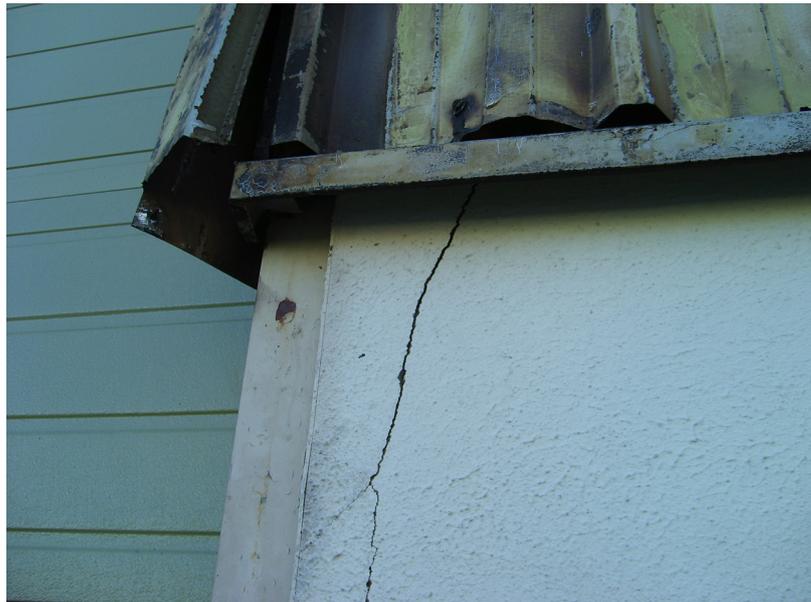
- 4.4 The proprietary wall board at the right side of the up and over door (adjacent to where the front of the vehicle had been) had cracked as a result of heat (see Photograph 8 at Annex 3). However, even at this location the outer and inner skins of the Kingspan insulated panels (KS 1000 RW) were found to be intact with no deformation (the distortion to the steel covering and drip flashing visible in the photograph were as a result of actions during the investigation on 28th October 2008).

Photograph 8. The lower edges of the Kingspan insulated panels (KS 1000MR) immediately above the blockwork wall adjacent to where the vehicle cab had been after the edging had been pulled away. The proprietary wall board had cracked as a result of heat.

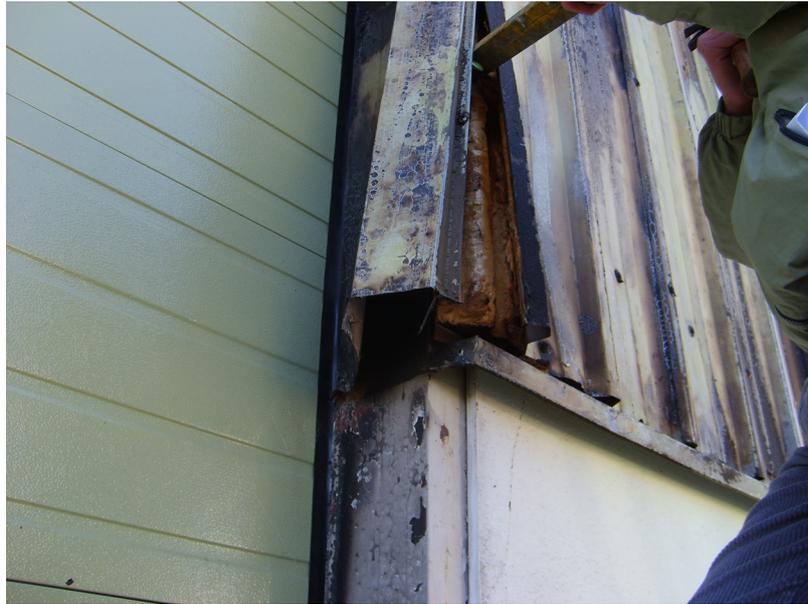
- 4.5 The lower edges of the Kingspan insulated panels (KS 1000 RW), immediately above where the proprietary wall board had cracked with the heat, were prised open. The inner core had charred only at the edge nearest the roller-shutter door. The core had remained in-situ and there was no evidence of deformation or delamination (see Photographs 9 & 10 at Annex 3). In addition, there was no evidence that the core of the Kingspan insulated panels (KS 1000 RW) had assisted fire spread.

Photograph 9. The lower edges of the Kingspan insulated panels (KS I000MR) immediately above the blockwork wall immediately adjacent to where the vehicle cab had been. The insulation had only charred at the edge nearest the up and over door.

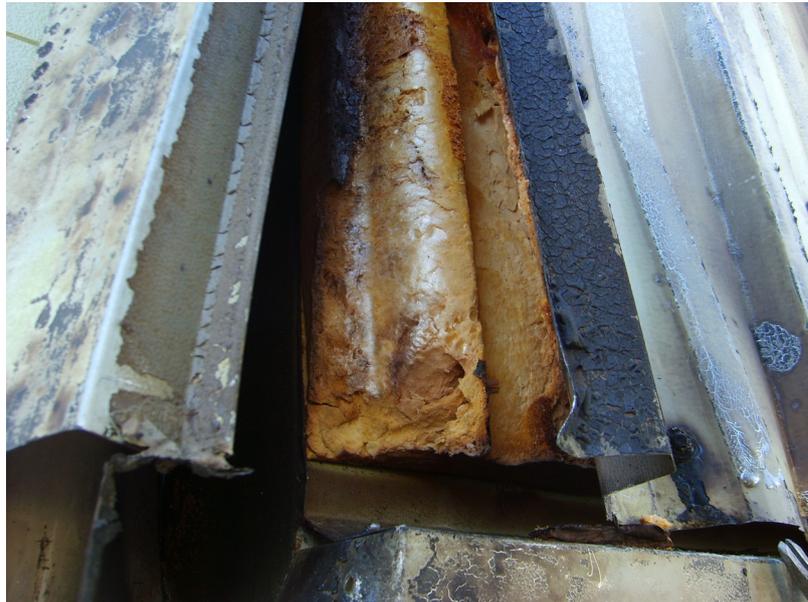
Photograph 10. Close-up of the insulation exposed in Photograph 9 above.

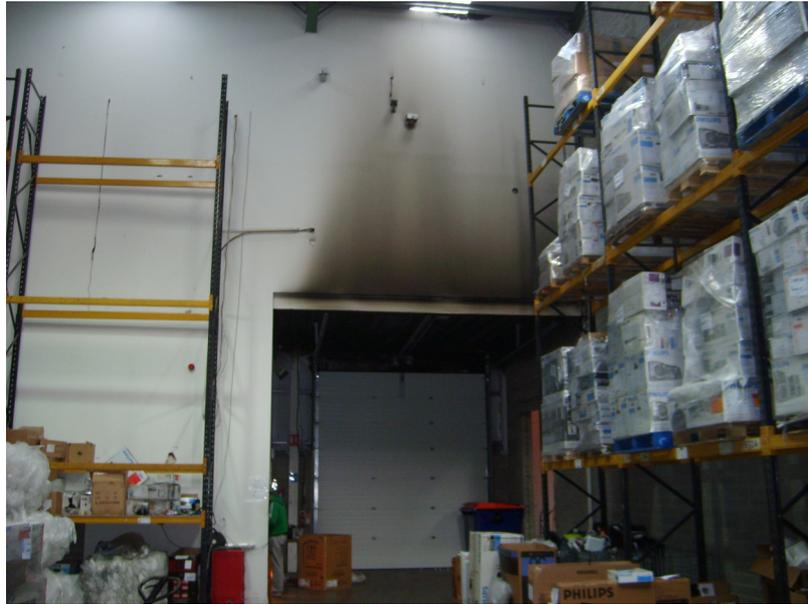
Photograph 11. Similar view to Photograph 4 above, showing the interior of the new up and over door, typical goods on racking and smoke staining to the wall above the 'tunnel' that separated the warehouse from the first floor offices.

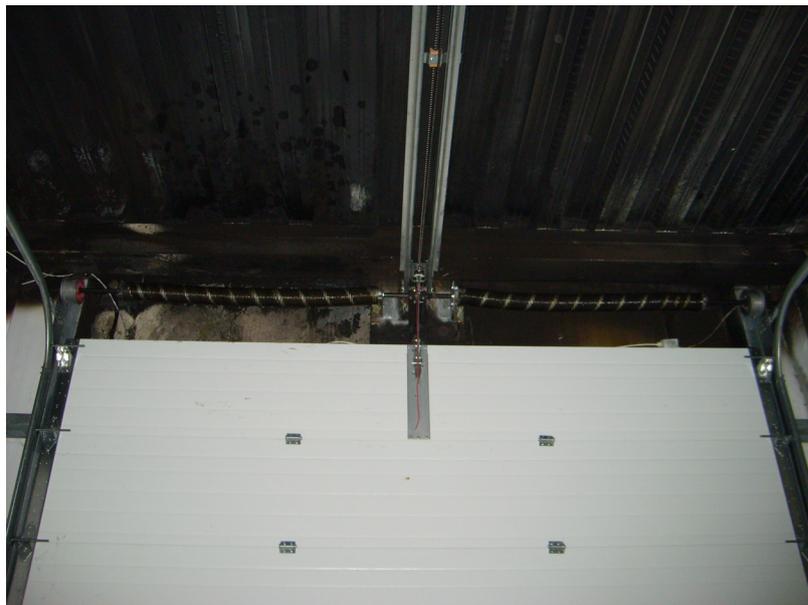
- 4.7 Photograph 12 at Annex 3 shows the interior of the Kingspan insulated panels, above the new up and over door. The smoke staining above the top of the door was limited to the surface of the cladding, suggesting that it was as a result of the smoke produced from the insulation in the door. There was no evidence that the core of the Kingspan insulated panels (KS 1000 RW) had had assisted fire spread.

Photograph 12. The interior of the Kingspan insulated panels, above the new up and over door, showing smoke staining from the original fire. This is the interior of the area shown in photographs a 6 and 7 above

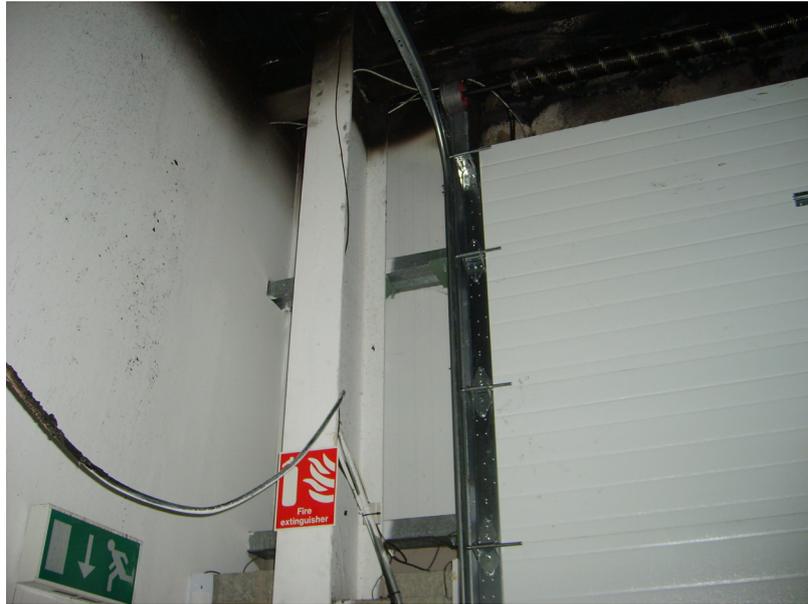
- 4.8 Photograph 13 at Annex 3 shows the interior of the Kingspan insulated panels (KS 1000 RW), at the side of the up and over door. The smoke staining was limited to the surface of the cladding at high level and at a similar level to that of the interior blockwork wall. If the Kingspan insulated panels had contributed to the fire or assisted spread, there would have been fire damage from a point at the top of the external blockwork wall i.e. approximately in line with and above the point where the fire extinguisher sign was fixed to the steel column shown in Photograph 13. This again suggests that the smoke staining was as a result of the smoke produced from the insulation in the up and over door. There was no evidence that the core of the Kingspan insulated panels (KS 1000 RW) had assisted fire spread.

Photograph 13. The interior of the Kingspan insulated panels, at the side of the new up and over door, showing smoke staining at high level from the original fire. This is the interior of the area shown in photographs at 8, 9 and 10 above.

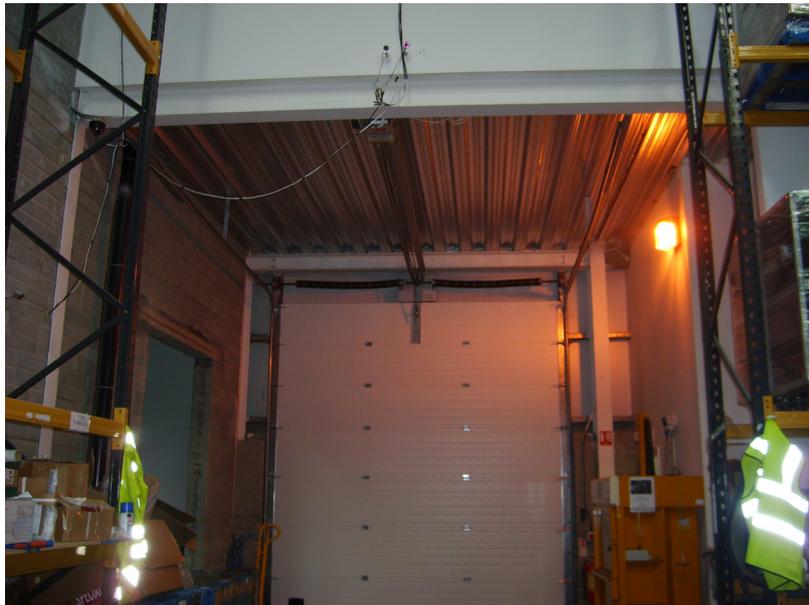
- 4.9 Photograph 14 at Annex 3 shows the interior of the second 'tunnel' (similar image to Photographs 4 & 11) that showed no signs of smoke staining on the ceiling of the 'tunnel' or on the wall above. Photographs 15 and 16 show the interior of the first floor offices (clad with Kingspan insulated panels) showing internal damage limited to dirty footprints. It is clear from these photographs that the smoke created by the vehicle fire and from the roller-shutter door did not enter the interior of the warehouse or the offices via the Kingspan insulated panels (KS 1000 RW).

Photograph 14. The interior of the second 'tunnel' (similar image to Photograph 11) showing no signs of smoke staining on the ceiling of the 'tunnel' or on the wall above.

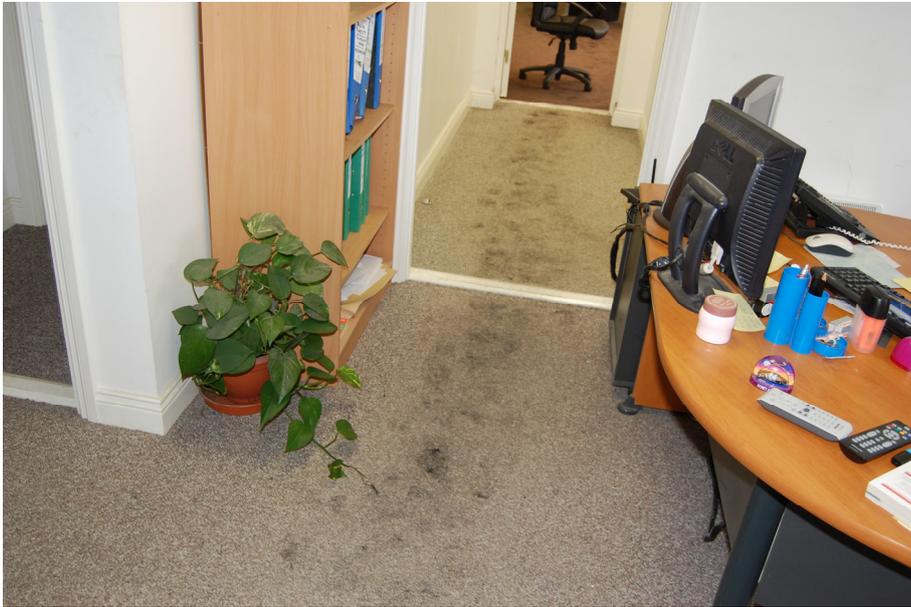
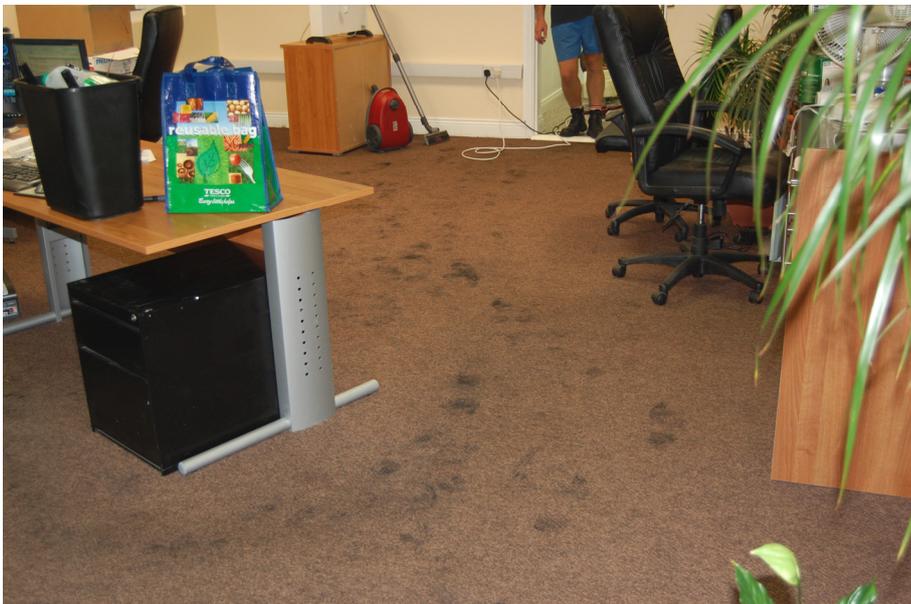
Photograph 15. The interior of the first floor offices (clad with Kingspan insulated panels) showing internal damage limited to dirty footprints.

Photograph 16. The interior of the first floor offices (clad with Kingspan insulated panels) showing internal damage limited to dirty footprints.
