▶ REPORT INTO A FIRE AT RA WOOD
ADHESIVE TAPES CANNOCK ON 5
NOVEMBER 2009

TS09199-R01-ISSUE 1

for:
Kingspan Ltd
GreenField Business Park No 2
Greenfiled
Holywell
Flintshire
CH8 7HU

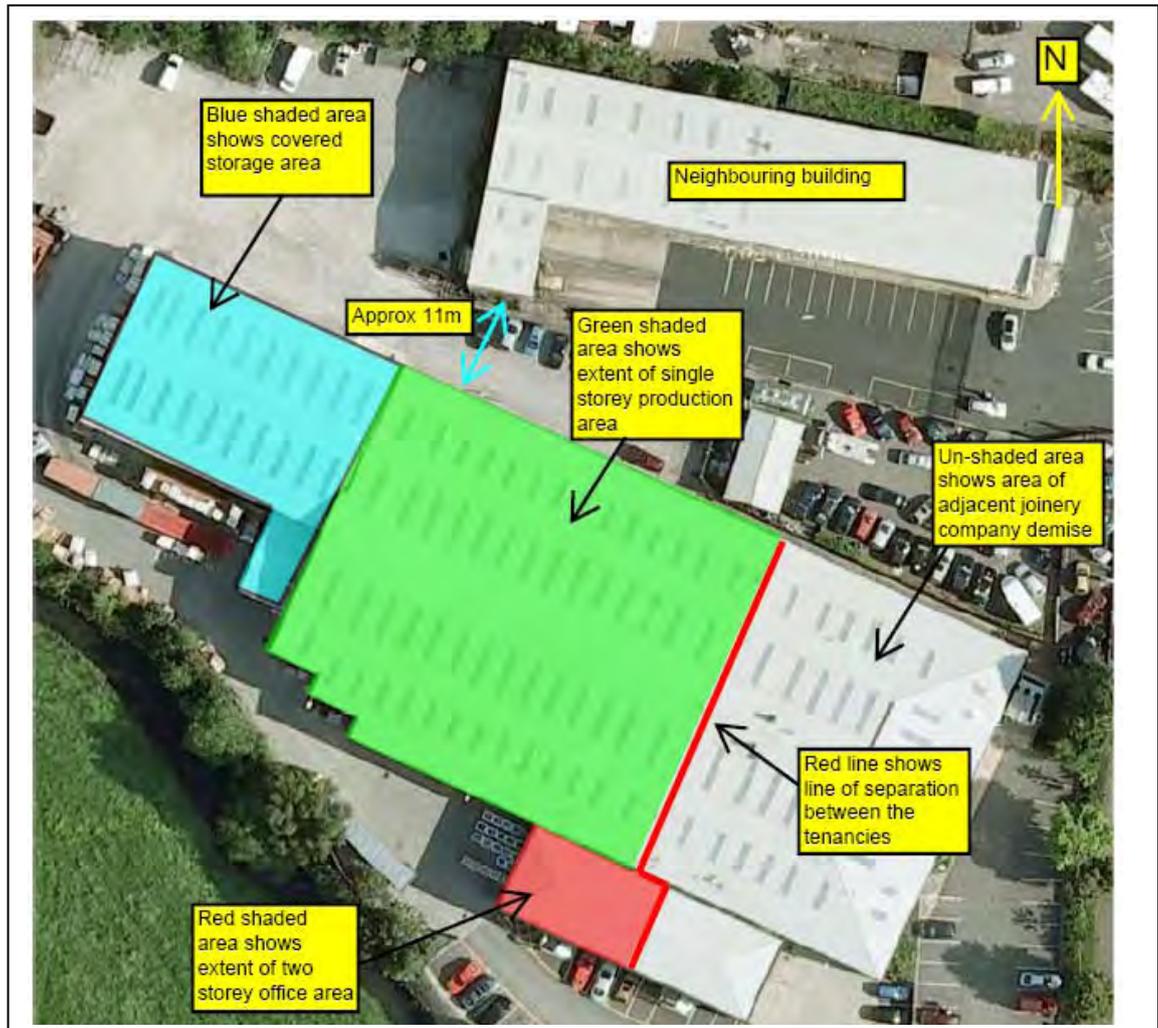
Figure 2 - Aerial view of site before fire

2.7 To the western extremity of the building, it is understood that a covered storage area abutted the main building and had been constructed using lightweight structure and cladding. This was completely destroyed by the fire and had been demolished by the time of the site inspection on 16 November.

2.8 Figure 2 shows an aerial view of the site taken from Google Maps. The image has been marked up to indicate the location of the covered storage area and the wall dividing the two tenancies.
